LOSS LESSONS

VOLUME 6

A SPRINKLER HEAD SAVES A FACTORY

REPORT PUBLISHED BY
ALLIANZ RISK CONSULTING

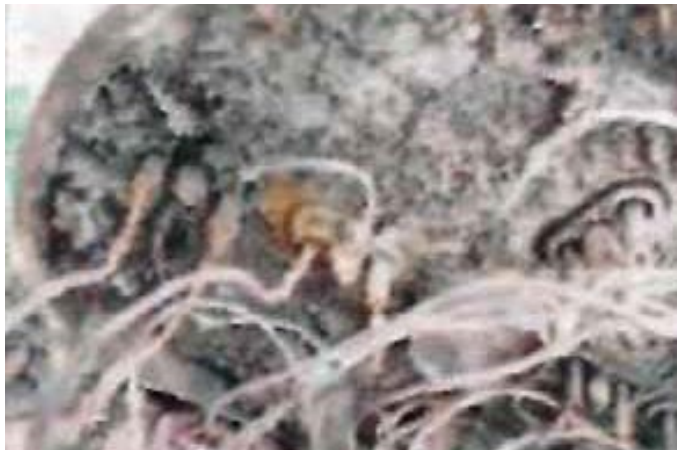
The fire seems to have started due to electrical causes related to a short circuit in the humidifier. The humidifier's fuses had not blown. The initial fire spread to the adjacent cable runs (for a length of about 4 m) and to the rest of the humidifier, as well as to an air conditioning housing located above it.

The fire was caused by the failure of the fuses following the short circuit on the humidifier. The presence of combustible electrical components: electric wiring runs, plastic materials, and of combustible insulation of the A/C ducts (polyurethane foam) contributed to spread of the fire beyond the humidifier.

↑ The resistance-coil laden cover on the humidifier where the fire broke out

Installing properly calibrated magnetic/thermal circuit breakers is more effective than using fuses for protection from short circuits. This type of protection should be supplemented by a differential breaker that can eventually provide earlier cut-off as soon as stray current is detected.

Conducting infrared thermographic inspections is a good means of prevention for detecting overheating in electrical and mechanical systems, or of detecting steam leaks and other defects that constitute extreme heat sources. This improvement was also made at the site following the fire.

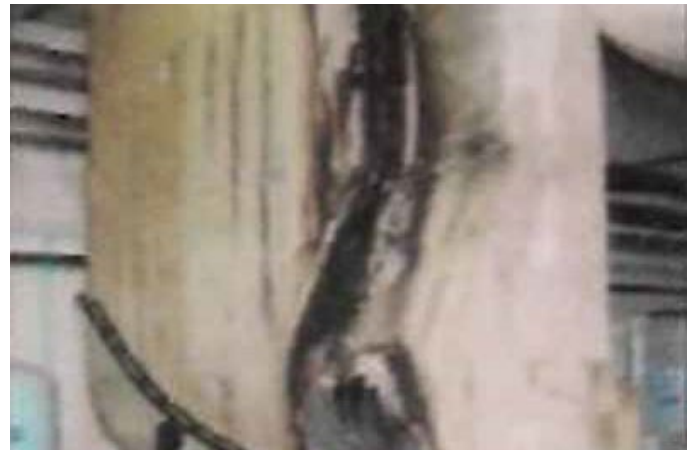
The fire was quickly kept from spreading and was put out by means of a single sprinkler head. There was relatively little damage. Only the humidifier, the thermal insulation on an A/C unit and the BMS circuit boards present in the utility room were damaged, and there were no business interruption losses since every effort was made to return to business as usual when the employees began work.

↑ The damaged humidifier and A/C casing
