LOSS LESSONS

EXPLOSION AND FIRE IN A FELT PREPARATION WORKSHOP

REPORT PUBLISHED BY
ALLIANZ RISK CONSULTING

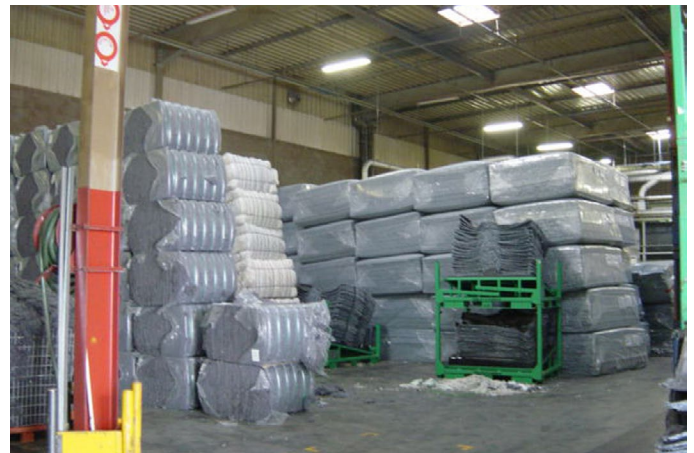
- Since the compartmentalization between the preparation zone and the storage zone was inadequate, it was unable to prevent the fire from spreading (concrete lower part and metal sheeting on the upper part)
- The massive stocks of raw materials nearby (reaching a height of nearly 7 m, in piles and on racks) fed the fire, thus causing severe damage to the building. The sprinkler system was not up to the task (60 sprinkler heads triggered on a system designed to supply a maximum of 30 heads)
- The plant was equipped with an infrared spark detection system, normally quite reliable, which seems not to have worked
- The filters and mixing box were not equipped with explosion vents

Huge stocks of materials in the processing zones that need to be reduced

- Installation of purge procedures for the transfer ducts when a fire starts, with systematic verification that they are applied
- A new design for the preparation area intended to reduce the risks of explosion: isolation of the waste products recycling line and elimination of the mixing box
- The use of new types of dust filters with a lower risk of explosion (rotary filters or auto de-plugging filters), installed outdoors as much as possible
- Outfitting of filters and any equipment subject to a risk of explosion with explosion vents directed toward the outside of the building. Installation of equipment that is compliant with the recommendations of the new ATEX directive (European directive 94/9/EC: installation of equipment in areas at risk for dust explosion)
- Regular inspection of the spark detection system
- Limiting the amount of stock kept in processing zones

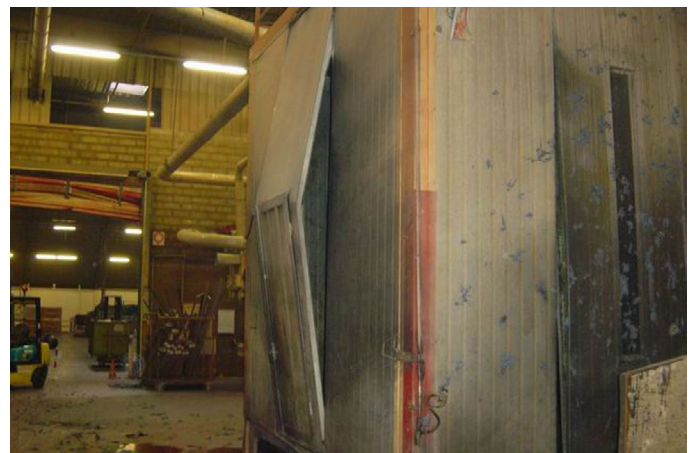
The most likely hypothesis is as follows: fire broke out in the felt tunnel the evening before, at around 8 p.m. The selvages produced by cutting the felt are recycled to a tearing machine and then go to the bale press or the mixing box. An ember ended up being recycled to the mixing box and set off the explosion.

Mixing box blown out by the explosion
