LOSS LESSONS

VOLUME 7

FIRE IN LIVING QUARTERS AT A RENOVATION WORK SITE

REPORT PUBLISHED BY
ALLIANZ RISK CONSULTING

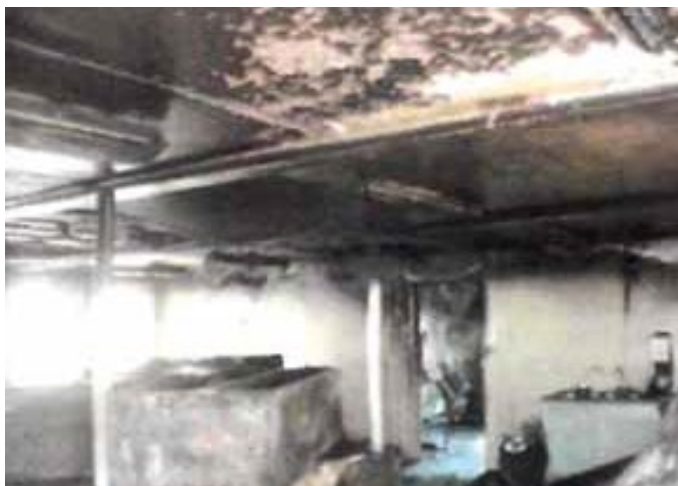
- An electrical cause: this cannot be ruled out, although the fire started in the bathroom and dressing room area (few electric appliances)
- Vandalism: This is to be included since there seem to have been two separate points where fires started. Since there were no cases of bodily injury, the police investigations did not pursue this line
- A careless smoker: This seems to be the most plausible hypothesis given the hour (soon after the workers left the work site) and the fact that smoking was allowed in the living quarters area.

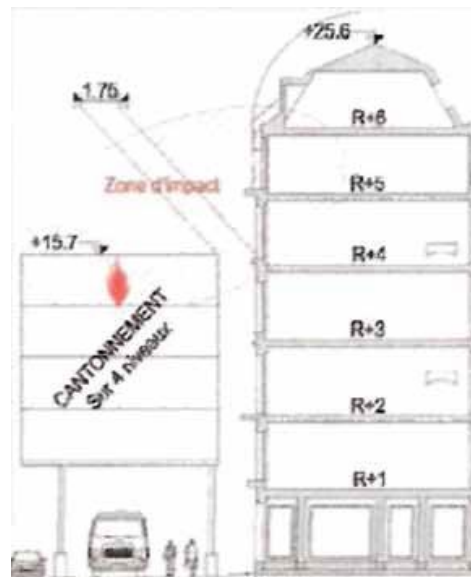
The fire started on the 4th floor of the living quarters, which holds the dressing rooms, bathrooms and dining areas for the workers from the various sub-contractor companies (+/- 120 people involved) and totally gutted it.

- The 14 bungalows on the top level were destroyed by the fire and will have to be replaced
- The classified building façade, which was also under renovation, also sustained damage due to its proximity to the fire, even though the fire did not spread to this part. Damage there caused by smoke and heat radiation from the fire required scraping and cleaning more than 100 m² of façade and the replacement of a dozen doors and windows

- The presence of a highly-combustible polyurethane foam core layer in the sandwich panels on the sides of the bungalows that caused rapid horizontal spread of the fire on the 4th level, as well as the abundant heat and smoke emissions that damaged the building's façade and made it difficult for the firemen to intervene

↑ 4-floor shelters area affected

- Keeping temporary structures such as living quarters, storage areas and waste collection zones away from the work site, or placing them in fire-cutoff compartments in relation to the work site
- Not using bungalows with combustible thermal insulation
- Setting up and maintaining in working order a secure back-up supply of electric power
- Installing smoke detectors with alarm transmission in all areas of the living quarters and storage areas
- Ensuring that living quarters and work site areas are equipped with a sufficient number of fire extinguishers (see French APSAD Regulation R4 or equivalent standard outside France)
