LOSS LESSONS

VOLUME 12

FIRE LOSS OF A MATURATION/ DRYING AREA OF POLYURETHANE BLOCKS AVOIDED THANKS TO A SPRINKLER SYSTEM

Reference LL 12/18/12

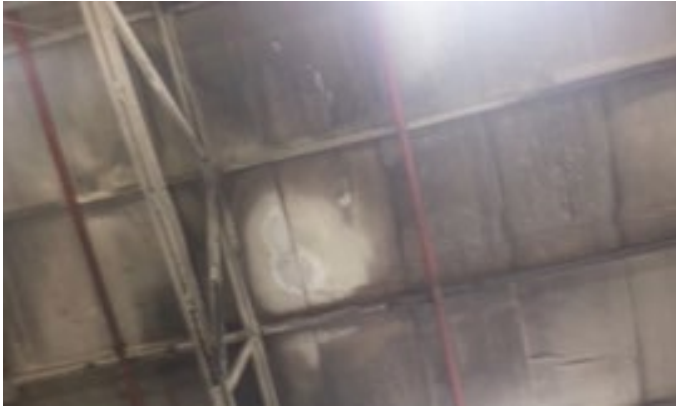
- The replacement of 40 m² / 430 ft² of the roof area damaged during the fire development by smoke and hot gases

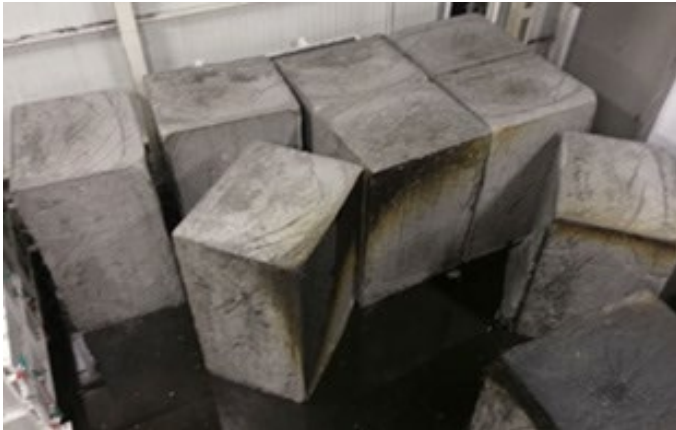
- The loss of a dozen of polyurethane foam blocks

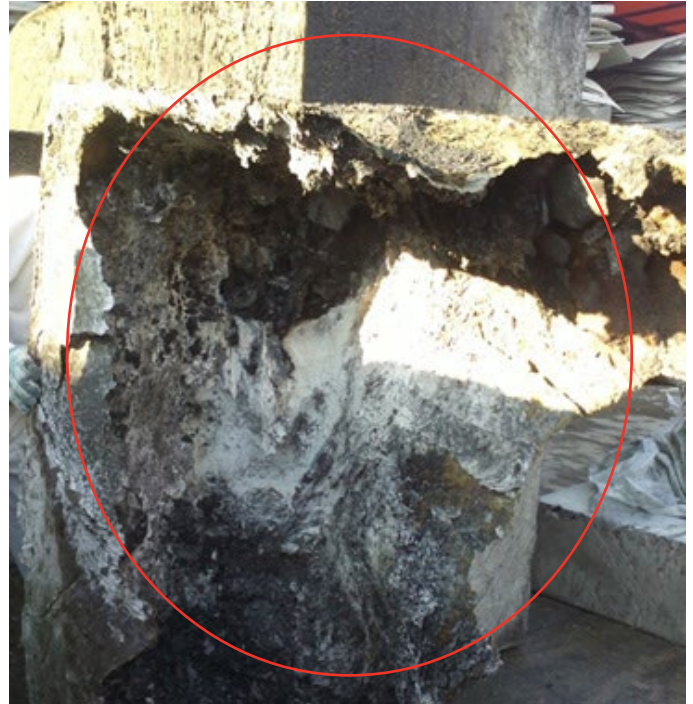
The start of fire has been located in one of the polyurethane foam blocks (self-ignition).

Polyurethane Foam Block at the origin of the fire

An erroneous composition of one of the raw materials has permitted the exothermic reaction to continue, resulting in the self-ignition of one of the foam blocks. Laboratory analysis showed that the water concentration of one of the raw materials was too high (10 times the maximum limit according to the information on the product delivery slips).

The following quality controls shall be performed right after the demoulding step of the foam blocks:

- The surface roughness shall be controlled: if the surfaces are rough, it indicates that the reaction isn't finished and that there is an increased fire hazard
- The dimensions of the block shall be checked: if the dimensions are below the standard dimensions, when the quantity of raw material is stable from one batch to another one, it means that the reaction is abnormal and that there is an increased fire hazard

The characteristics of the raw materials delivered by the suppliers should be checked by sampling to insure the characteristics are in line with the ones needed for the process.
