LOSS LESSONS

VOLUME 6

A SPRINKLER HEAD SAVES A FACTORY

REPORT PUBLISHED BY
ALLIANZ RISK CONSULTING

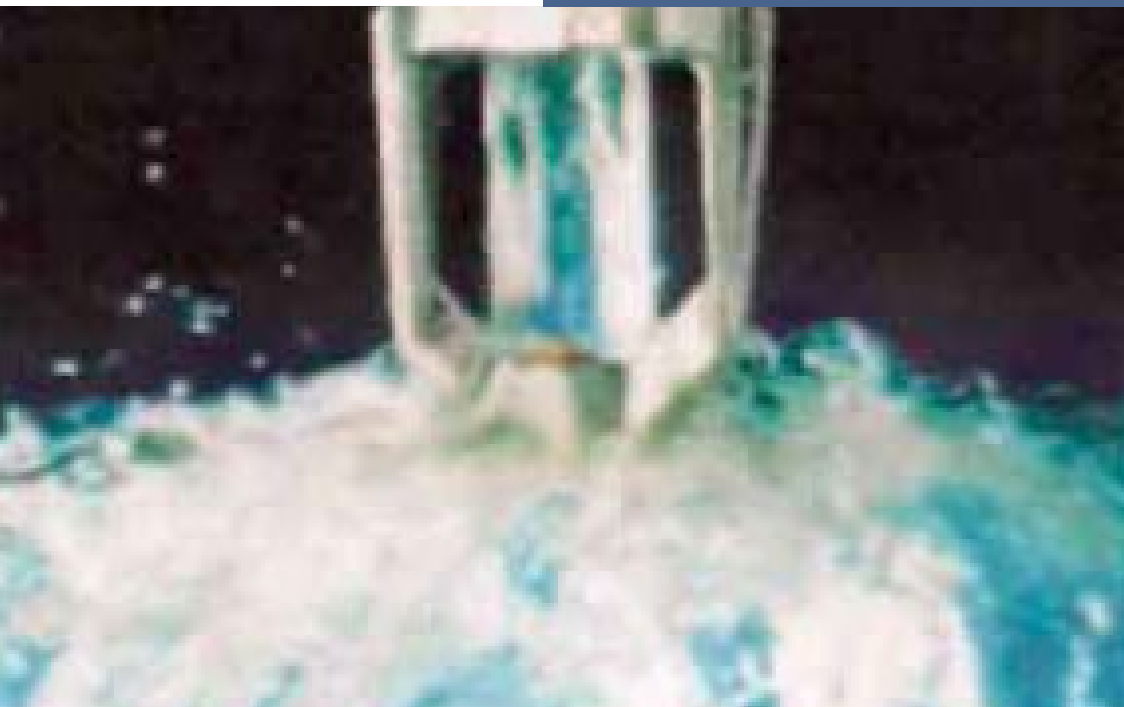
The fire seems to have started due to electrical causes related to a short circuit in the humidifier. The humidifier's fuses had not blown. The initial fire spread to the adjacent cable runs (for a length of about 4 m) and to the rest of the humidifier, as well as to an air conditioning housing located above it.

↑ The damaged humidifier and A/C casing
