LOSS LESSONS

EXPLOSION AND FIRE IN A FELT PREPARATION WORKSHOP

REPORT PUBLISHED BY
ALLIANZ RISK CONSULTING

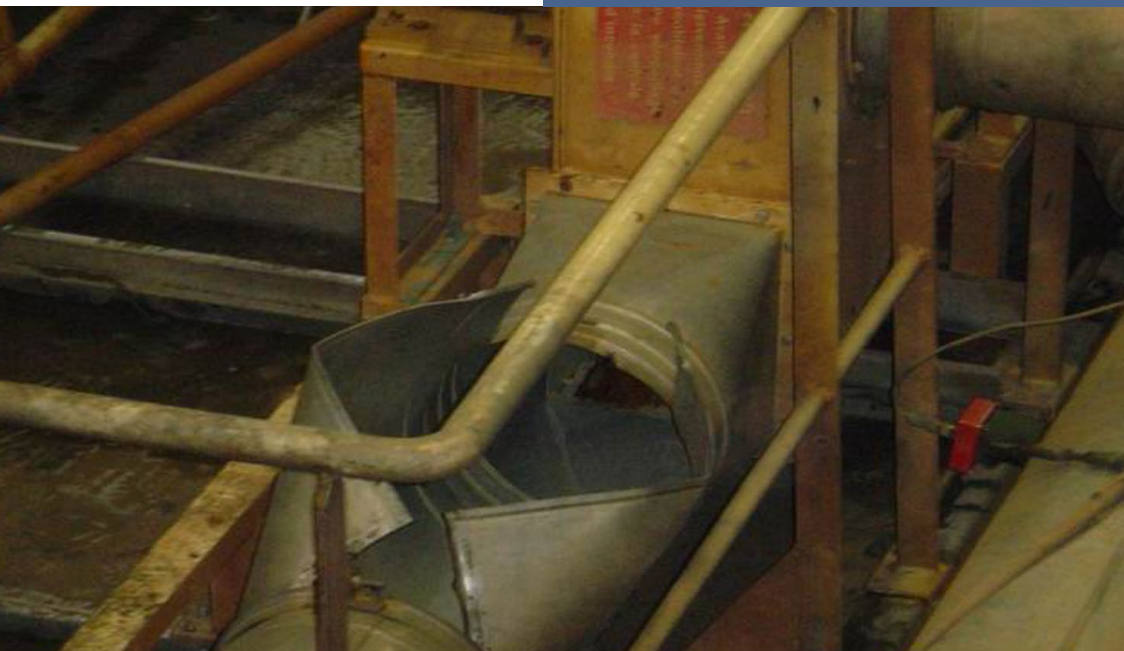
The explosion occurred in a dust filter and associated fiber mixing box at around 5:40 a.m. while the plant was in operation. Flaming material, projected by the explosion, set fire to various machines and to two mass storage areas: bins of felt remnants in the preparation zone and felt reels on racks in the Trimelt preparation zone.

- Damage to the building comprised the metal framing, 400 m² of roof, metal sheeting, 8 smoke extractors and the concrete wall between the preparation area and the felting line
- Preparation equipment (filter, loader, spinner, sleeve filter, ballot press, transfer ducting, spark-detection system)
- Trimelt preparation equipment (rotary filter, sleeve filter, loader, collection pad)
- Loss of inventory (70 m³)
- Shut-down of the felt plant for repairs for three and a half months
