LOSS LESSONS

VOLUME 7

FIRE IN LIVING QUARTERS AT A RENOVATION WORK SITE

REPORT PUBLISHED BY
ALLIANZ RISK CONSULTING

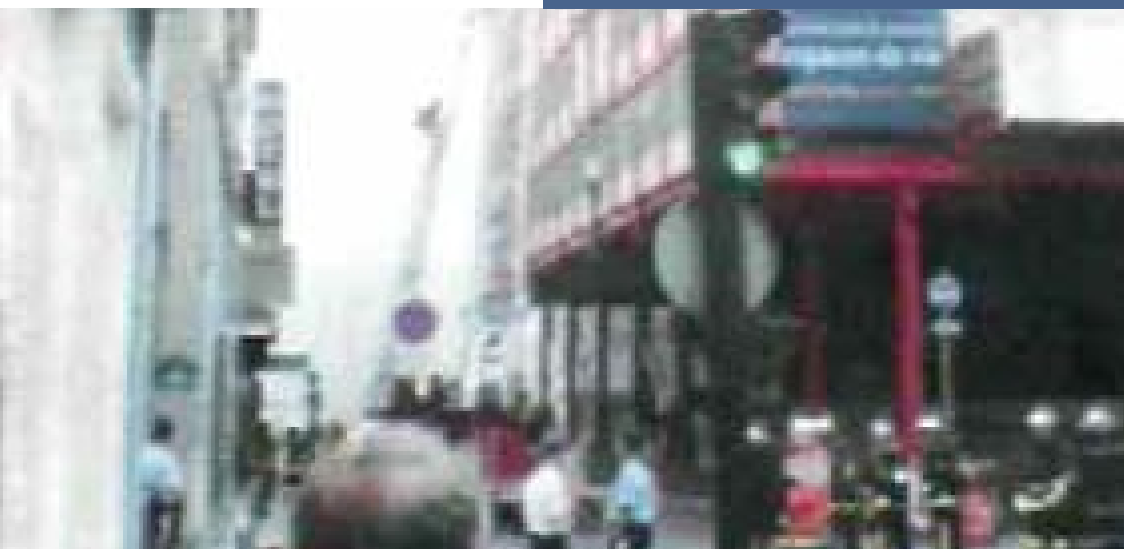
The fire broke out in the bungalows of the site's living quarters, installed the length of the façade, erected over the street, stacked 4 levels high and supported by metal trusses.

The fire started on the 4th floor of the living quarters, which holds the dressing rooms, bathrooms and dining areas for the workers from the various sub-contractor companies (+/- 120 people involved) and totally gutted it.

- The 14 bungalows on the top level were destroyed by the fire and will have to be replaced
- The classified building façade, which was also under renovation, also sustained damage due to its proximity to the fire, even though the fire did not spread to this part. Damage there caused by smoke and heat radiation from the fire required scraping and cleaning more than 100 m² of façade and the replacement of a dozen doors and windows
