LOSS LESSONS

MACHINERY BREAKDOWN ON A WATER TURBINE

REPORT PUBLISHED BY
ALLIANZ RISK CONSULTING

Hydropower Station

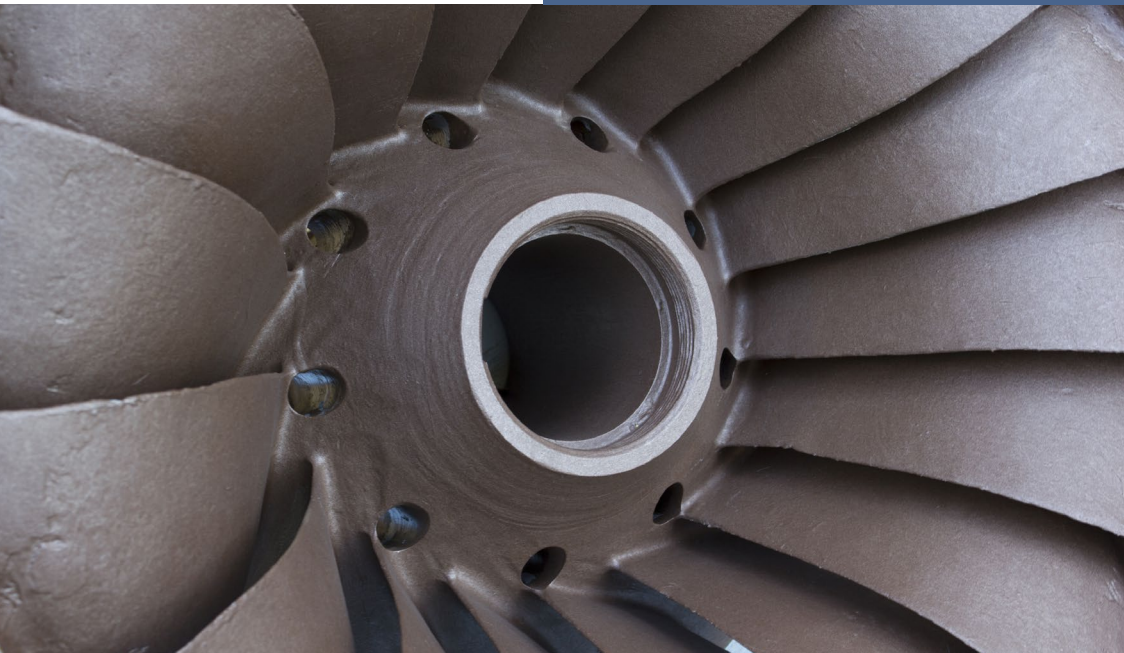
- Rupture of connecting bolts between the wheel and the shaft
- Metal rubbing on rotating parts
- Metal rubbing on stationary parts
- Journal bearing damage

Water pressure applied an axial load on the shaft line that is partially balanced by holes drilled into the hub of the wheel. These holes also allow the drainage of the bearing lubricating water. Loss was caused by a faulty design of the balancing holes. The flushing of the bearing was not correct (too low flow), the bearing overheated and clearance increased out of margins. Consequently, high vibrations and dynamic loads were developed by the turbine, bolts were over strained and broken, then the wheel dropped inside the stator.

The water turbine unit was not fitted with on line vibration and temperature monitoring. Overheating and abnormal vibrations were not detected by the remote control system.

Commissioning and start up phases would possibly be formalized with a certificate of completion. Tests and controls should be included in the acceptance procedure and these tests could be carried out in presence of all the parties involved in the works (client, engineering, contractor, manufacturer). It is a common interest to detect during erection abnormal operating conditions and it is easier to carry out changes before the end of works.

On line supervision of turbine with temperature and vibration monitors would allow the setting of a preventive maintenance and a reduction of the consequences of any failures or breakdown (cost and duration). Temperature and vibration are reliable indicators of mechanical condition for rotating equipment.
