HAZARDS OF ALUMINUM WIRING

ALLIANZ RISK CONSULTING

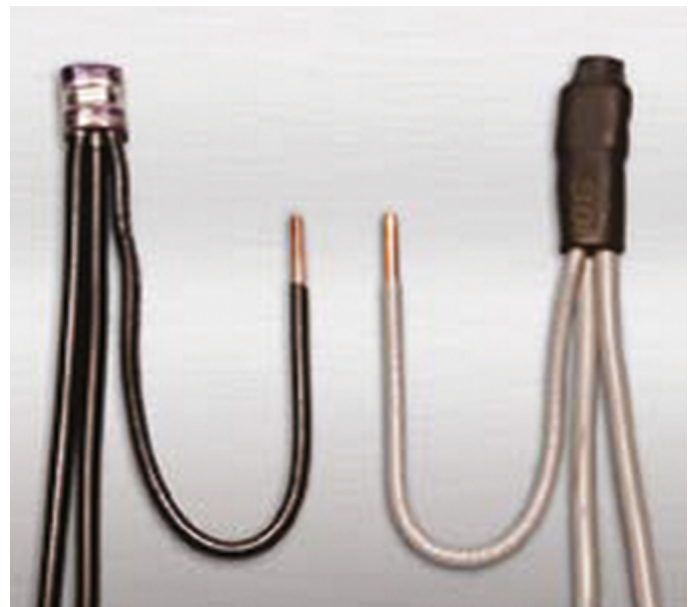
- Completely replace all aluminum wiring with copper wiring.
- The COPALUM repair method is recommended by CPSC on the basis of CPSC sponsored research, laboratory tests, and demonstration projects. This repair method has been thoroughly proven by more than a quarter of a century of field experience to provide a permanent, low-resistance electrical connection to aluminum wire. The COPALUM repair method eliminates the aluminum connection failure problems and still uses the existing, installed aluminum wire.

COPALUM Photo from CPSC Publication 516

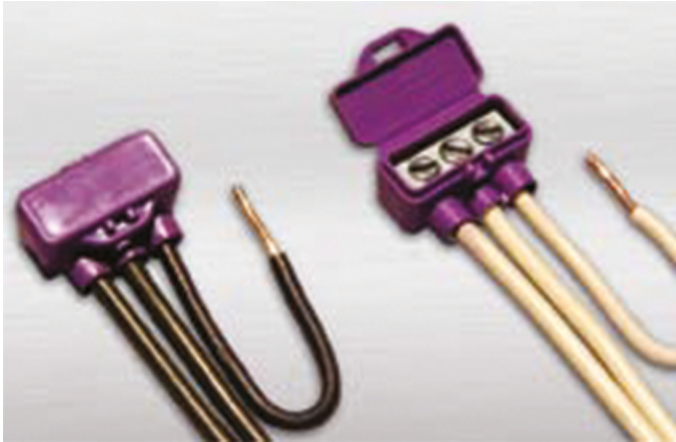
- CPSC staff recognizes that copper replacement may be cost prohibitive and that the COPALUM repair may be unavailable in a given locality. Based upon an evaluation that was, in part, CPSC supported, consumers are advised that, if the COPALUM repair is not available, the AlumiConn connector may be considered the next best alternative for a permanent repair. This repair method involves pig tailing using a setscrew type connector instead of the COPALUM crimp connector in the repaired connections.

AlumiConn Photo from CPSC Publication 516
