LOSS LESSONS

A RIDE-ON SWEEPER THAT MAKES A BIG ... MESS

REPORT PUBLISHED BY
ALLIANZ RISK CONSULTING

Manufacture of automobile parts

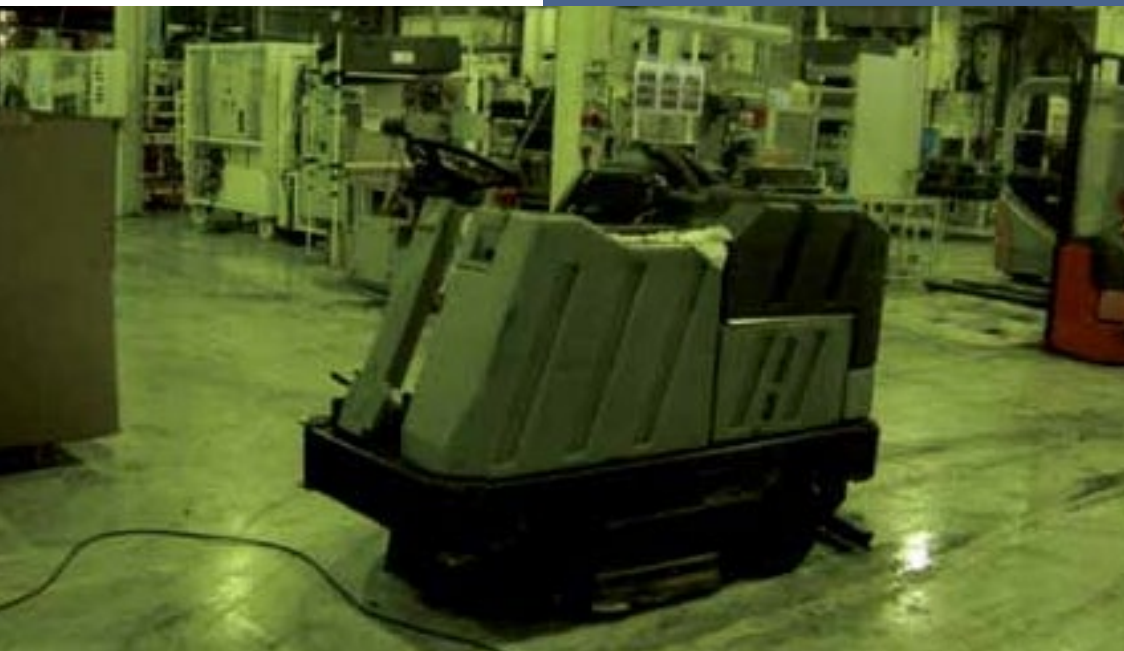
On October 10th, during a period of low production prior to departing for the weekend, only 9 people were present at the site when a demolding agent leak occurred in a supply hose located in the foaming workshop.

The hose in question supplies the demolding agent spray gun. The agent consists of a 98 % solvent mixture with a flash point of 26 °C. Despite the slow flow of the leak, it ended up creating a large puddle (30-40 m²) since no staff were in that zone. Following discovery of the accidental leak, the team leader requested that it be cleaned up. A ride-on sweeper was put into use but a spontaneous fire broke out underneath it.

The absence of a sprinkler system favored worsening of the situation. Uncontained, the fire quickly became intense and spread to the nearby production equipment. In addition, production stocks at the line heads fed the fire with combustible material.

- There were no injuries or deaths
- The 1,600 m² foaming workshop was severely damaged (nearly 30 % of overall site production facilities)
- Production equipment (foaming, thermal molding) is largely unusable. It will take a long time to replace the machines. However, all of the moulds were recovered, immediately repaired and sent to other Group sites
- Inventory located beside the lines was totally destroyed
- Massive amounts of smoke invaded the other production workshops and the offices, thus causing major soot damage
- Interruption in the delivery of finished products was avoided by using the repaired moulds installed at other sites
- The cost of damage to the production machines is estimated to be €7Mn
- The cost of damage to the buildings is estimated to be € 1Mn
- Various additional costs, such as for special transportation, are estimated to be at less than €500,000

The poor condition of the spray hose led to a solvent leak.

- Replace, if possible, the demolding agents containing solvent with water-based ones in order to substantially reduce the risks resulting from solvent-laden vapors (ATEX zone); otherwise, automatic fire-protection systems will be required

- Hoses should be checked regularly and included in a preventive maintenance program to control the risk of rupture
- Signage must be placed on the cleaning machines with wording prohibiting their use to clean up inflammable liquids

The scope of the incident is related to the absence of a sprinkler-type automatic fire protection system. The site was identified as critical due to the absence of an automatic fire extinguishing system. This recommendation had been documented during assessments conducted, and a project to install a sprinkler system was under study. The factory will be rebuilt equipped with a sprinkler protection system.

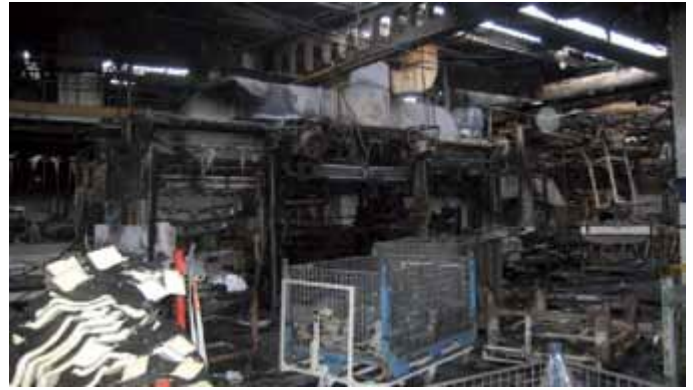
↑ ... after!

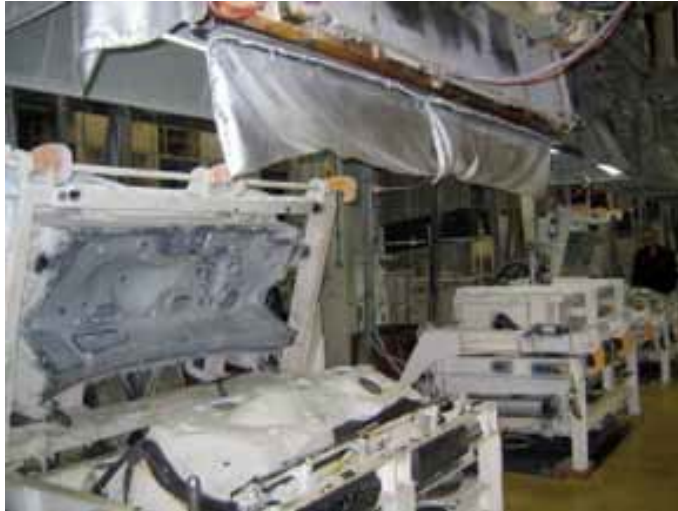
↑ Before ...
