LOSS LESSONS

A SMOKY WARNING THAT COULD HAVE BEEN EASILY AVOIDED

REPORT PUBLISHED BY
ALLIANZ RISK CONSULTING

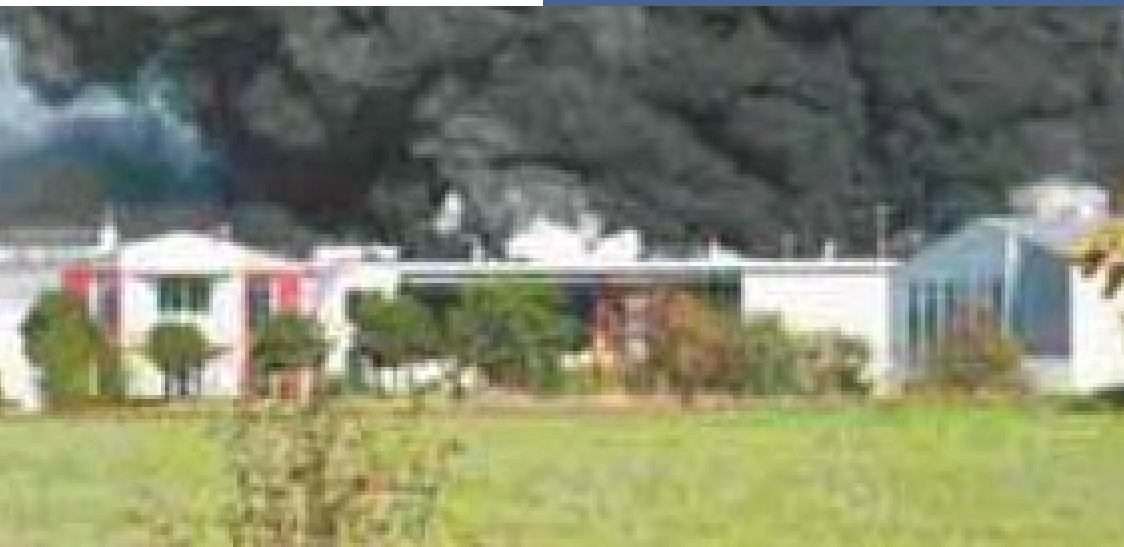
- Half of the raw materials and finished products stock was burned completely
- 2,500 m² of the canopy were destroyed. The roof and the wall of the production building (metal frame and mineral wool insulated metal cladding as well as bituminous felt on the roof) were damaged by heat radiation from the fire
- The smoke that had entered massively into the production building led to the deposit of a thick soot layer on the production equipment and the interior building structures
- The production activities in the building were only impaired until the next day (to allow clean up)
- Delivery of finished products to the clients was hampered for only a few days

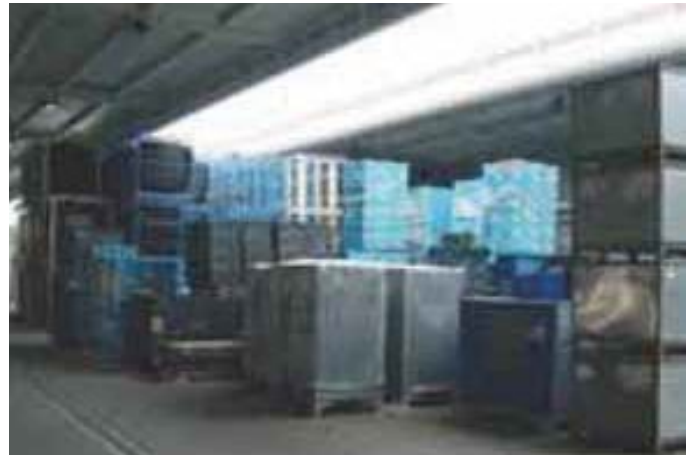
↑ Before ...

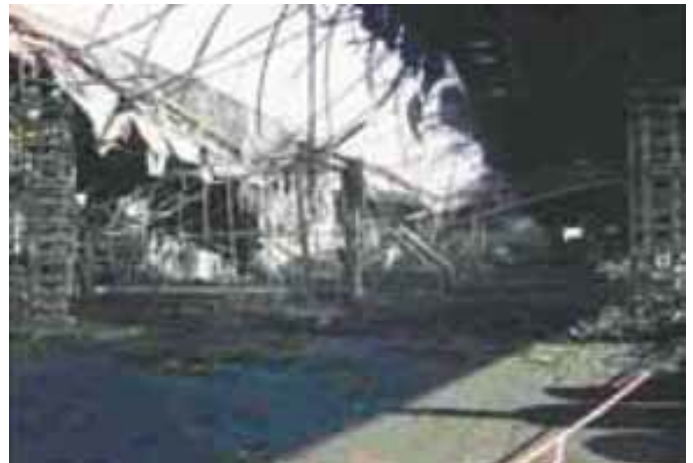
↑ ... after!
