LOSS LESSONS

VOLUME 10

FIRE IN A FINISHED PRODUCTS WAREHOUSE

REPORT PUBLISHED BY
ALLIANZ RISK CONSULTING

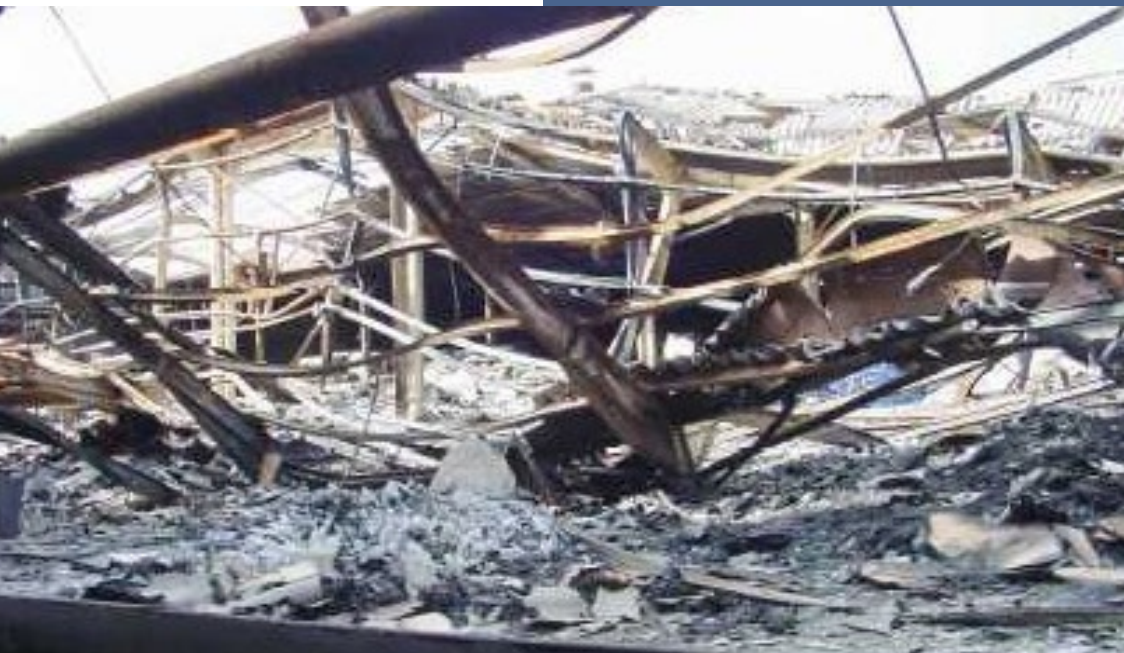
- Total destruction of the warehouse and spreading to part of the production area
- Interruption of production for less than 1 week

- The design of the metal frame building: major deformations due to the high temperatures reached
- The corrosive nature of the smoke, which caused additional damage to the machines (no production down-time, but additional cost of decontamination)
- The spread of the fire, which was facilitated by the types of products stored : some "separator/film" type products made of polypropylene and polypropylene seem to have been partially stored in the area dedicated to finished products, which substantially increased the combustible load present
- The lack of a water-based sprinkler system
- The absence of smoke-extraction vents, which favored the spread of hot gases within the production area
- The fire brigade being prevented from going into the building on fire: the fire was initially attacked from the outside due to the risk of the building collapsing

Experience with this type of incident shows that, in order to limit a fire's impact, the separation of risks is a fundamental aspect of fire prevention. It is essential that any fire that starts and is poorly controlled not be allowed to easily spread to all of the premises. Using fire-walls to compartmentalize warehouse zones constitutes a safe and effective means of limiting damage from a fire. The installation of a sprinkler system would have contained the fire and helped prevent its development and spreading.

Implementation of previously recommended safety and protective measures could have avoided or limited the fire.

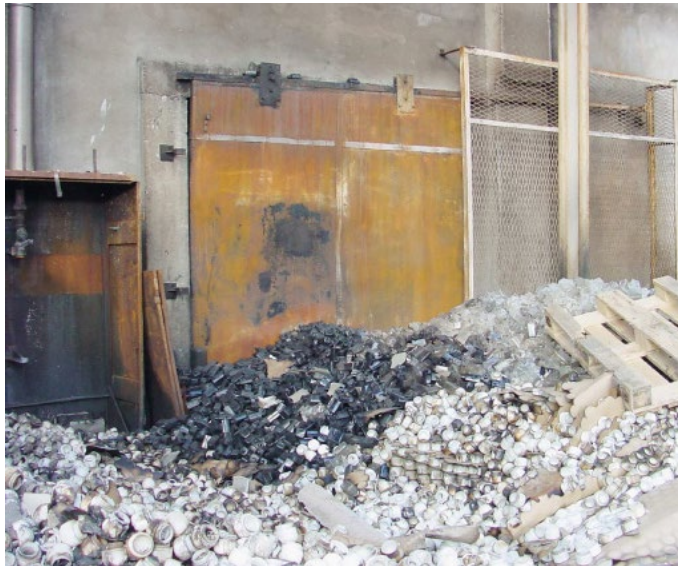
After the fire, on one side of a fire door ...

- The presence of an effective fire-wall, which served to keep the fire from spreading and saved the other storage compartments
- Several fuse-operated fire-doors that closed automatically when the temperature rose
- Quick response by the fire brigade as soon as they were alerted. They were familiar with the company and the effective safety measures in place made their operation easier
- The dedication and availability of the employees
- Measures were quickly taken to restart business operations based on excellent cooperation between the insured party and loss adjusters
- The intervention by a company specialized in rapid decontamination after fires to treat the production equipment subjected to corrosion by the chlorinated vapors

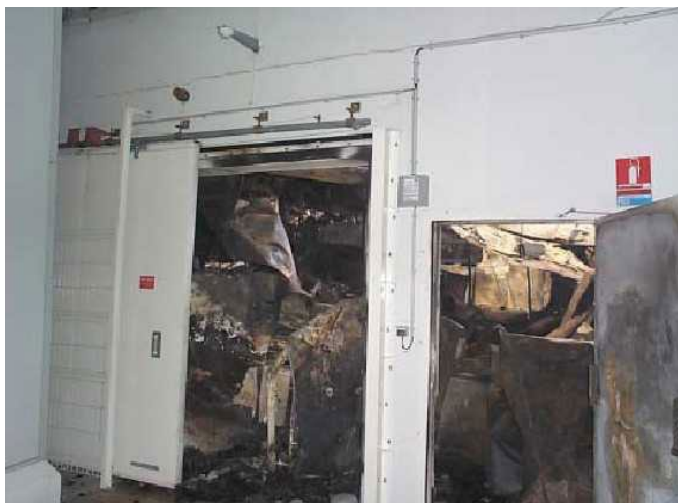
... and on the other side
