# LOSS LESSONS

# OUTDOOR PALLET STORAGE: A BLAZING INFERNO

REPORT PUBLISHED BY  
ALLIANZ RISK CONSULTING

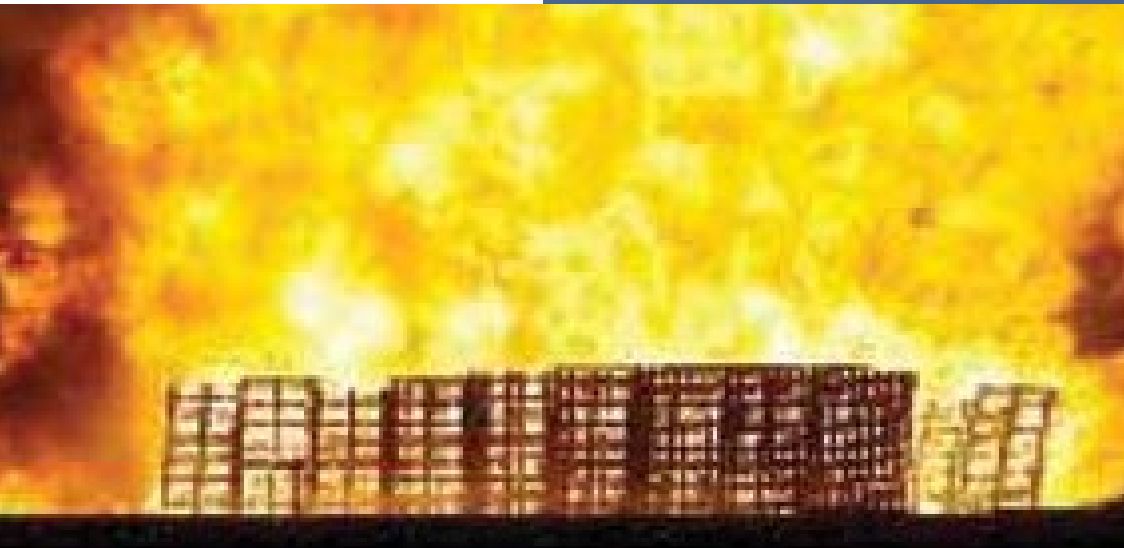
During the night of the 4<sup>th</sup> of May, at 1.15 AM, the outdoor storage of stockpiled idle wooden pallets of a metal packaging manufacturer was completely destroyed by fire. Approximately 30,000 pallets were lost, in spite of the action of the plant's Emergency Response Team and Fire Department. This action has, however, reduced the damage to the storage building located 10 m away from the pallets, and has also allowed to keep all the other buildings safe from the fire.

- 30,000 idle pallets destroyed
- Metal racks and frames stored in the vicinity either damaged or destroyed
- Two trailers for racks and pallets parked nearby destroyed
- Storage building damaged (partial replacement of claddings and access doors, partial re-roofing, replacement of plastic skylights and rainwater drains, cleaning of the soot deposits)

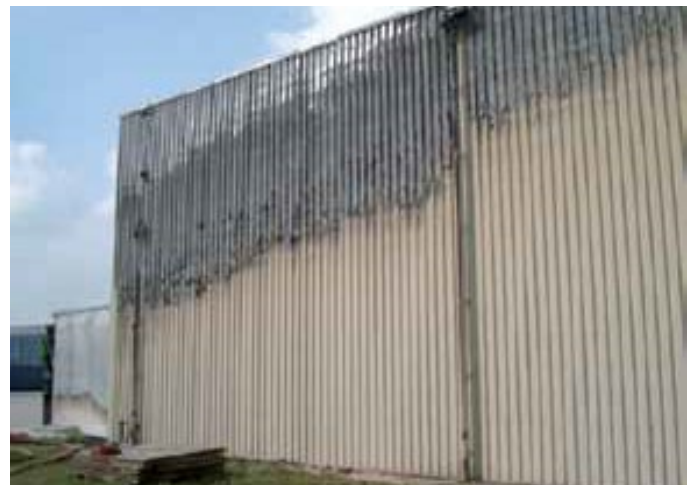
↑ Building damaged by heat exposure

- The lack of clear distance between the outside idle pallets storage, the metal racks and frames storage and the trailers parking area, leading to their destruction due to heat exposure
- The insufficient clear distance (10 m) between the idle pallets storage and the storage building, leading to damage to this building due to heat exposure, in spite of the Fire Department reaction. This distance was too low, regarding the high quantity of pallets and their storage arrangement
- The lack of aisles between each block storage of pallets which could have prevented the fire from jumping from a block storage to the next one

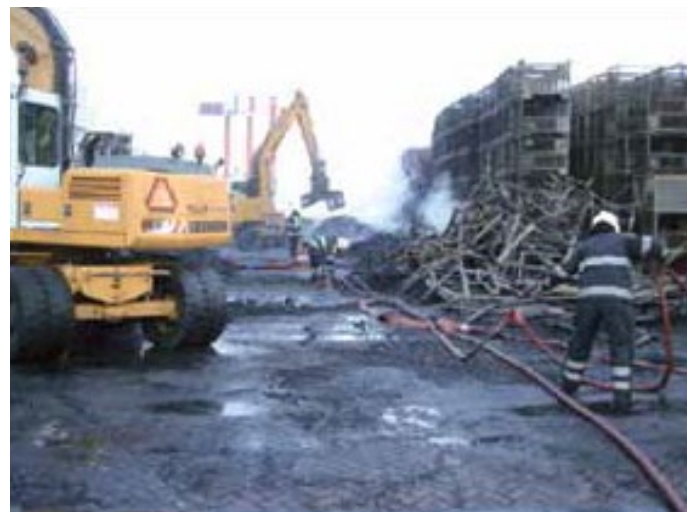
↑ Destroyed and damaged racks and frames
